Manhole Inspection Summary

Manhole # S15C__017MH

Location Address: **REAR 2594 EDMONSON**

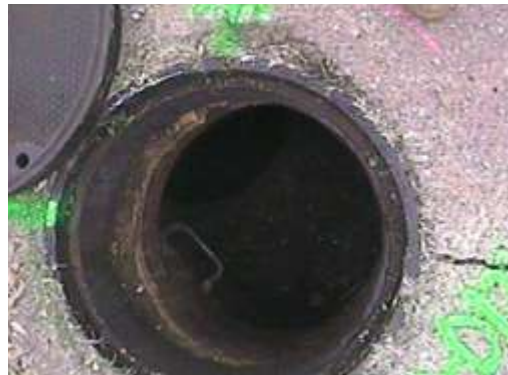
Defect 4

Frame Offset: **2** (in.) Condition: ☒ Sound ☐ Cracked ☐ Leaks

frame offset

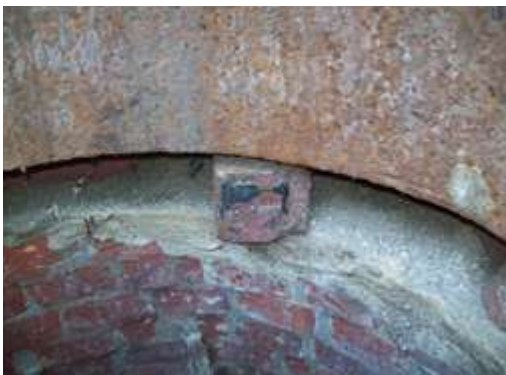
Defect 2

Condition: ☐ Sound ☒ **Cracked** ☐ Root Intrusion ☒ **Loose Brick** ☐ Deteriorated

loose bricks

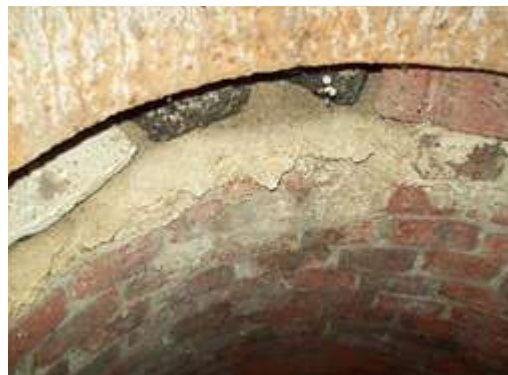
Defect 1

cracked chimney

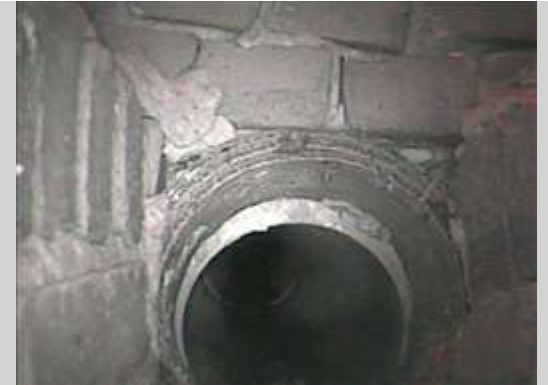
12 O'Clock Outflow

8 in. Circular Gravity Sewer
Pipe Out @ 12 O'Clock

Pipe Height: (in.) Direct
Pipe Material: **Clay** ☐ Pipe Lined
Invert Depth: **11.36** (ft.) Flow Characteristics: **Slow**
Deposits: ☒ None ☐ Mud ☐ Sludge ☐ Debris ☐ Grease
Silt Depth: (in.) Deposits Extent:
Infiltration: **None** Pipe Seal Cond: **Sound**

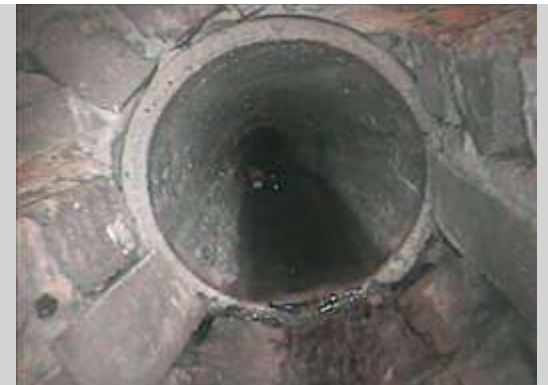
3 O'Clock Inflow

8 in. Circular Gravity Sewer
Pipe In @ 3 O'Clock

Pipe Height: (in.) Direct
Pipe Material: **Clay** ☐ Pipe Lined
Invert Depth: **11.16** (ft.) Flow Characteristics: **Slow**
Deposits: ☒ None ☐ Mud ☐ Sludge ☐ Debris ☐ Grease
Silt Depth: (in.) Deposits Extent:
Infiltration: **None** Pipe Seal Cond: **Sound**
